# Cyclone Nargis storm surge in Myanmar

**Cyclone Nargis storm surge in Myanmar**

# After the storm

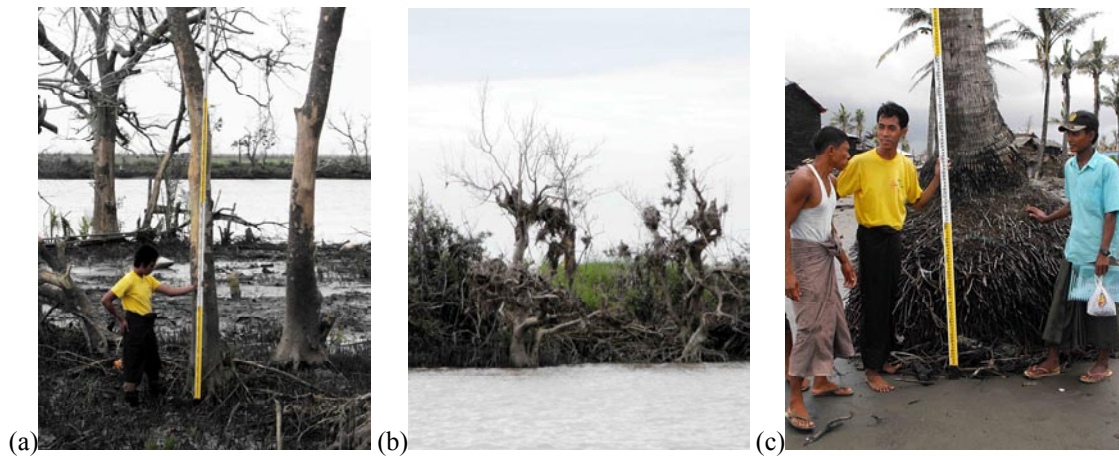
Supplementary Fig. 2. Field survey: (a) bark damage and (b) rafted debris in trees as high water marks at Pyinsalu; (c) vertical erosion on palm tree roots at Aung Hlaing.

Ephemeral coastal erosion, and vegetation and infrastructure damage were documented. More than 1 m of vertical erosion and 100 m of land loss were measured at various coastal locations from the landfall area to the Ayeyarwady river mouth (Supplementary Fig. 2). Drinking water wells were flooded with saltwater, scoured and left stranded in the surf zone. A golden Buddhist stupa, originally built on dry land, pierced the water surface 150 m offshore from Aya. Deforestation for charcoal and rice paddies as primary land-use had left few primary growth mangroves, which may have provided some wave attenuation<sup>6</sup> within 30 km of the coast (Supplementary Fig. 3).

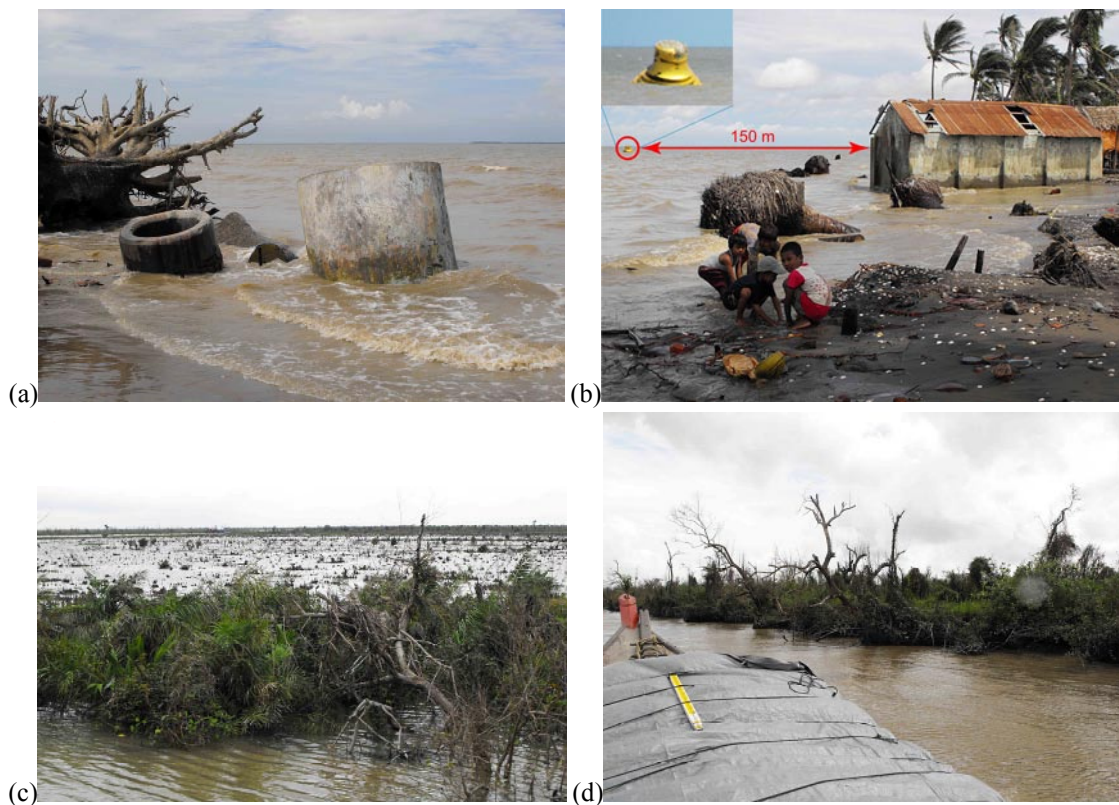
Supplementary Fig. 3. Coastal erosion: (a) Drinking water wells scoured in surf zone at Aya; (b) Golden Buddhist Stupa built on land piercing the water surface offshore highlighting 150m land loss. Land use: (c) Deforestation of mangroves for use as charcoal and rice paddies; (d) Secondary growth mangroves with cyclone damage in a forestry reserve.

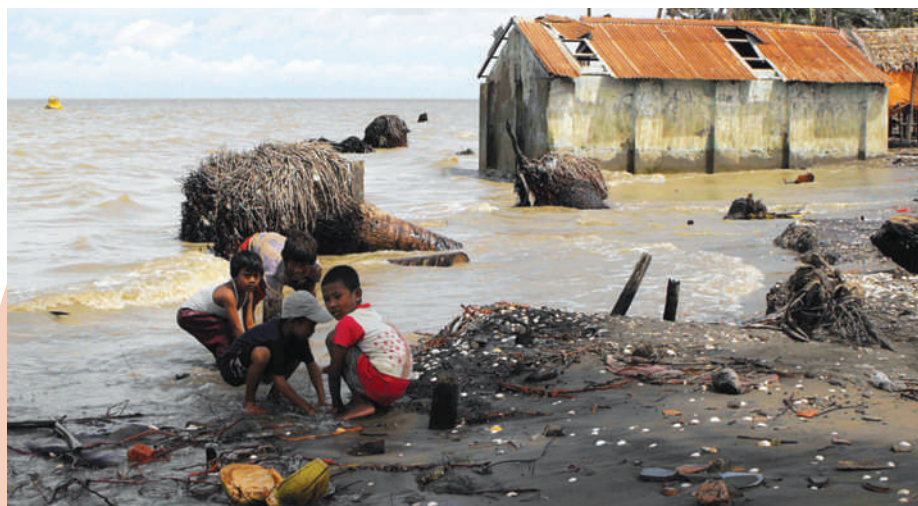
Coastal erosion and land loss at Aya near the Ayeyarwady estuary, Myanmar. At the top left you can see the golden Buddhist stupa — originally built on dry land — piercing the water surface 150 m offshore.

The discovery of a centuries-old golden Buddhist stupa piercing the milk coloured coastal waters offshore Aya was the highlight. For once the monsoon clouds opened and the bright sunlight appeared to put a spotlight on the scene. The stupa had originally been built on dry land, but it now marks the largest documented coastal erosion due to storm-surge flooding.
